Wilson Creek - Mankato

Preliminary Findings and Recommendations

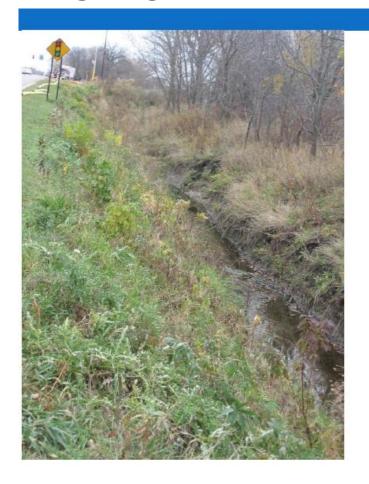
- Identified needs:
 - Potential slope failures and sloughing
 - Relatively steep banks, near traveled way
 - High velocities
- Potential improvement
 - Continued vegetation management
 - Flow reduction

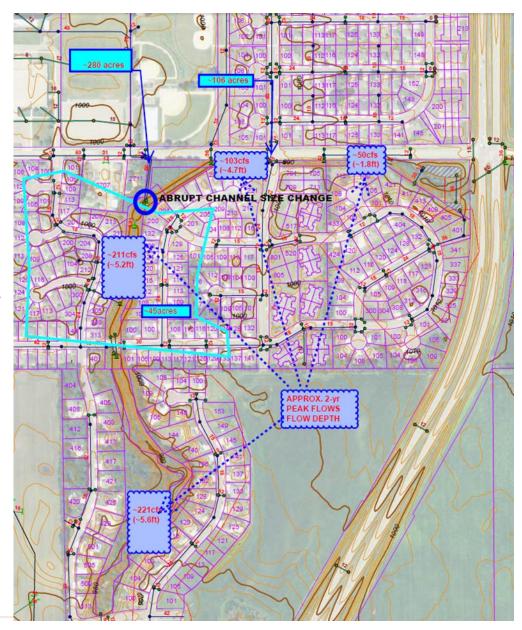
- Abrupt Increase in Peak
 Flows downstream of large
 Culverts Outlets (Zone 2 to
 Zone 3 transition)
 - Results in Channel Widening
- Large increase in peak flow due to runoff from the urbanized area north of Hoffman Road
 - Area drained by a dense storm sewer system.
